ecological effects of the Christchurch February earthquake on our city rivers

summary &
management
recommendations

Environment Canterbury report no. U11/6
ISBN: 978-1-927195-83-3

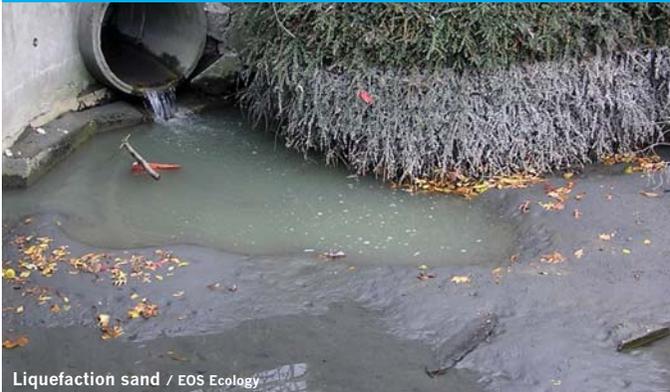
Liquefaction sand / EOS Ecology

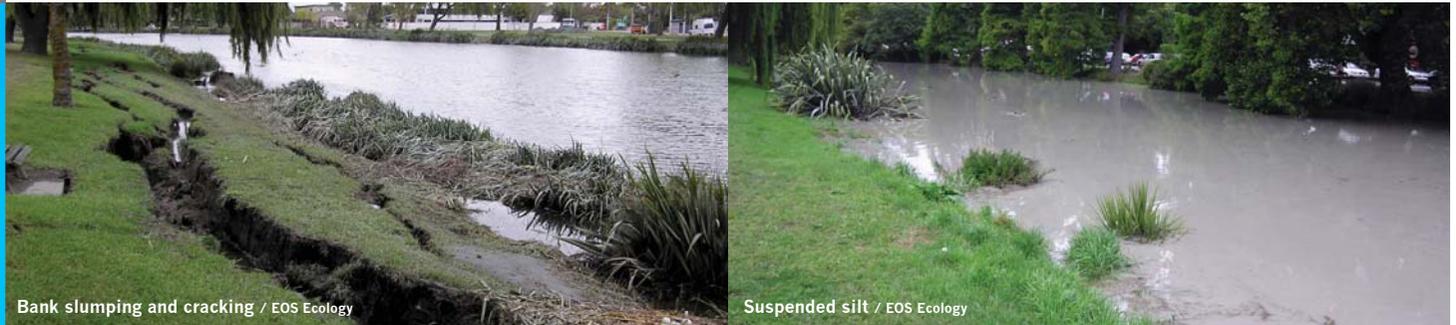
Bank slumping and cracking / EOS Ecology

Suspended silt / EOS Ecology

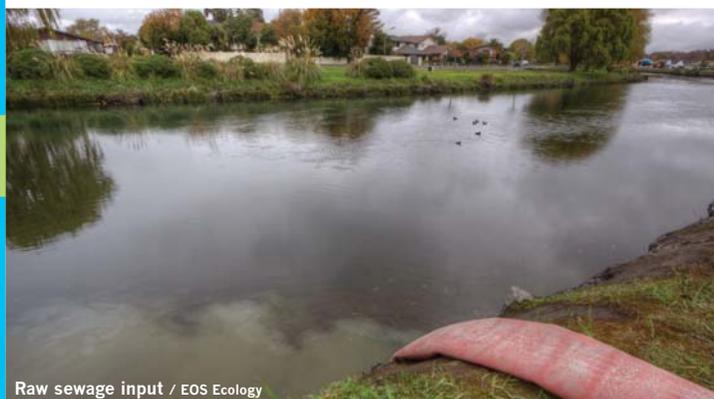
Immediately following the February earthquake, large volumes of wastewater were discharged into the river. For example, on 15 March an estimated total of 35,000 m³ per day of wastewater was discharged, but by 28 April discharges had reduced to about 13,300 m³ per day. In late April/early May both modelled and observed ammonia concentrations were below ANZECC guidelines for either chronic or acute toxicity at the lower wastewater discharges.

Following the February earthquake, wastewater discharges of about 13,000 m³ per day could have caused severe de-oxygenation between the Opawa Rd Railway Bridge and Ferrymead, potentially causing significant fish kills. By 28 April, discharges had reduced to about 4000 m³ per day. Predicted and observed DO concentrations still suggested appreciable DO depletion, particularly between the Opawa Rd Railway Bridge to Ferrymead. In this stretch of the river DO concentrations were lower than ANZECC chronic guideline values for fish, and occasionally lower than the acute guideline values. Sensitive fish species may thus be adversely affected in this reach. Ammonia concentrations in April were below ANZECC guideline values for both chronic and acute toxicity.

Raw sewage input / EOS Ecology

For both rivers, it is recommended that if wastewater discharges approach the above recommended limit of 10,000 m³ per day (Avon) or 5000 m³ per day (Heathcote), then DO should be measured to confirm whether low DO is a problem, and identify what reach needs attention. Assessments should be made either early morning or over a full day-night cycle using strategically deployed data sondes. Once this confirmation has been made, aeration of either the wastewater or the receiving water should be undertaken. During this time, it is recommended that data sondes be deployed below the discharge points, and at the lower boundary of the reach to see whether reaeration is successful. NIWA staff can provide more specific advice if needed.

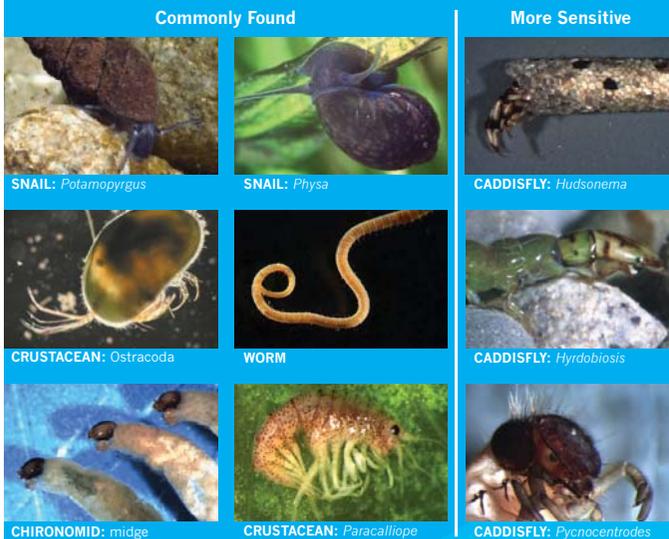
INVERTEBRATES FOUND POST EARTHQUAKE (a. Upper Wadeable River Study)

2 Effects on Aquatic Invertebrates

Historic data on the invertebrate communities at these sites allowed for a "before and after" comparison. The depth of fine sediment on the river bed increased most at the "sand/silt and wastewater" sites, and least at control sites. Such deposited sediment may have smothered cobbles in the streambed, possibly affecting invertebrates. The invertebrate community was dominated by taxa such as snails, crustaceans, midges, worms and caddisflies. Of the three categories, none displayed any consistent major change to invertebrate communities. However, small site-specific changes were observed, such as increases in relative abundance of snails in some control sites, and decreases in worms at a site affected by sand/silt inputs. The greatest earthquake related change was a large reduction in the relative abundance of caddisflies at the Kilmore Street site. Many other un-surveyed Christchurch streams have been subject to extensive liquefaction.

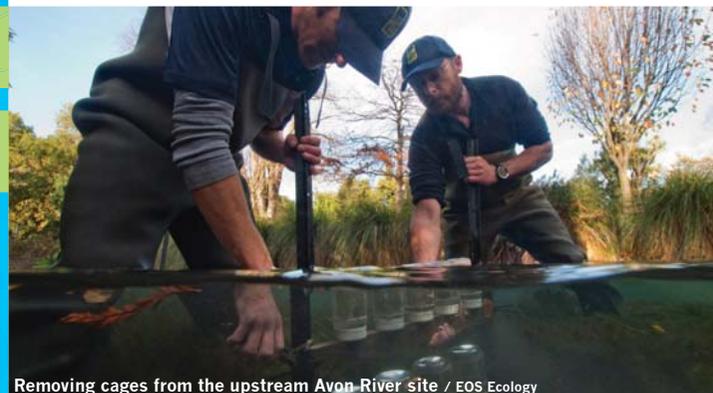
Removing cages from the upstream Avon River site / EOS Ecology

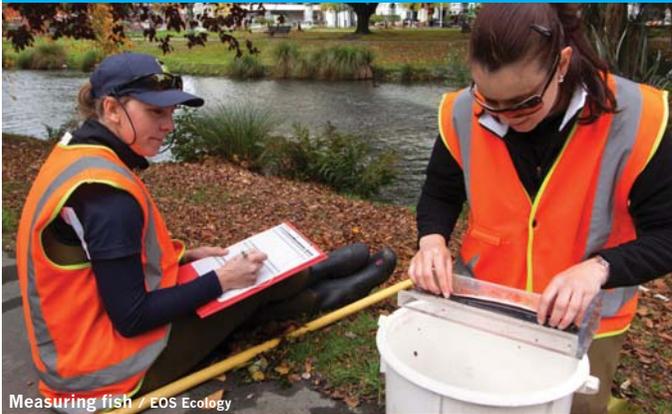
Measuring fish / EOS Ecology

All sites had previously been surveyed for fish, allowing a before and after comparison. The most common fish species were shortfin eel, common bully, and longfin eel. There was no evidence of mass reductions in fish abundance or a reduction in species as a result of the earthquake, despite wastewater inputs and sand/silt deposition. Subtle changes in fish distribution patterns throughout the Avon were noted, reflecting an increase in shortfin eel abundance and a decrease in common bully abundance. The most notable change was a reduction in the relative abundance of bluegill bullies at the Kilmore Street site, where caddisflies also declined.

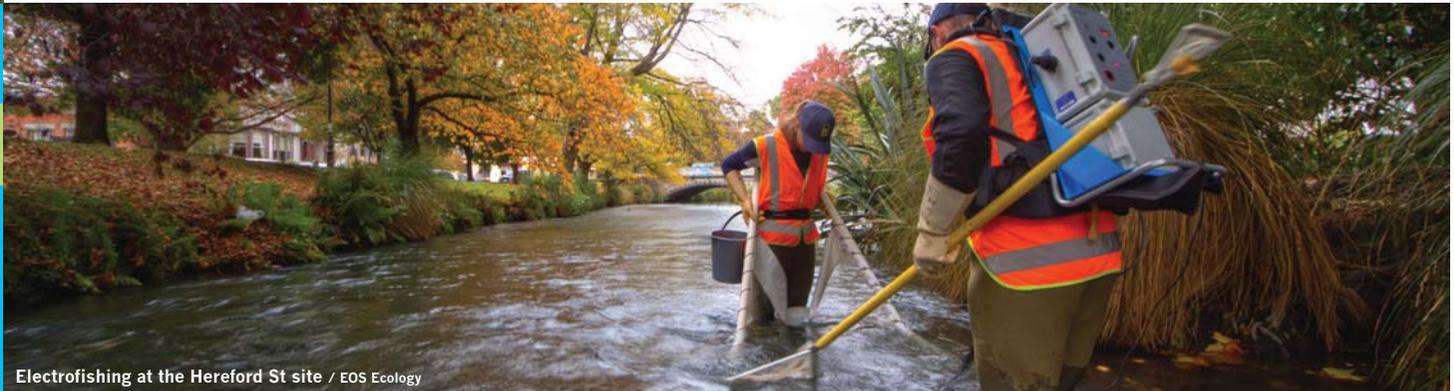
Electrofishing at the Hereford St site / EOS Ecology

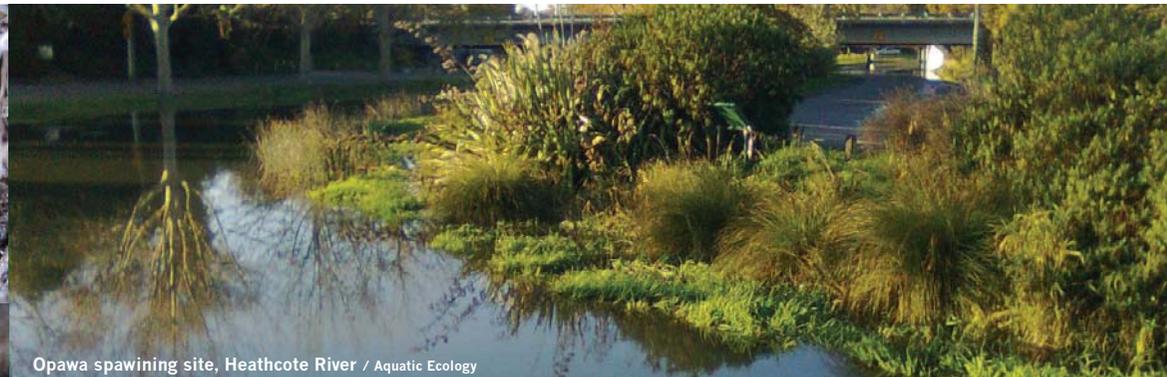
Seven known inanga (inaka/whitebait) spawning habitats on the Avon and Heathcote rivers were surveyed in April and May 2011 to determine if spawning was occurring, and to characterise the extent of earthquake related damage. Damage to sites was highly variable, ranging from minor to severe. Inanga eggs were observed at only the Avondale site, but this may not reflect earthquake effects alone. Some of the spawning sites were heavily overgrown by weedy species, reducing their spawning attractiveness. AEL identified specific management actions in order of ecological importance as follows:

Opawa spawning site, Heathcote River / Aquatic Ecology

1. Erect a silt trapping fence at the Avondale site to ensure silt does not enter spawning vegetation from remedial road works.
2. Weed control measures for yellow flag iris need to be maintained at Avondale.
3. Regrade and resow localised areas of lateral spread at Avondale to stabilise them.
4. Regrade and resow the Opawa spawning site to remove weedy plant species not conducive to spawning. Root mats in these plants were coated with silt, further reducing their spawning attractiveness.

5. Re-contour and replant the Lake Kate Sheppard site. Accumulated soft sediment on the lake's bottom should also be removed.
6. Narrow and deepen the lower channel Steamwharf Stream as banks have slumped badly.
7. Removal of liquefaction silt from the newly created areas in Corsers Stream.
8. Inter-tidal vegetation at Woolston Park was coated with fine silt, but this was expected to naturally self cleanse. Hand-weeding unwanted vegetation is all that is necessary.
9. Removal of unwanted vegetation is all that is necessary at the Amelia Rogers Reserve.
